THE PROJECT CONSISTS OF REMEDIATING THE ROCK CUT OF THE NORTH SLOPE BY EXCAVATION TO IMPROVE THE ROCK CATCHMENT AREA.

MUS-146-29.36

GEOTECHNICAL PROFILE - ROCKFALL

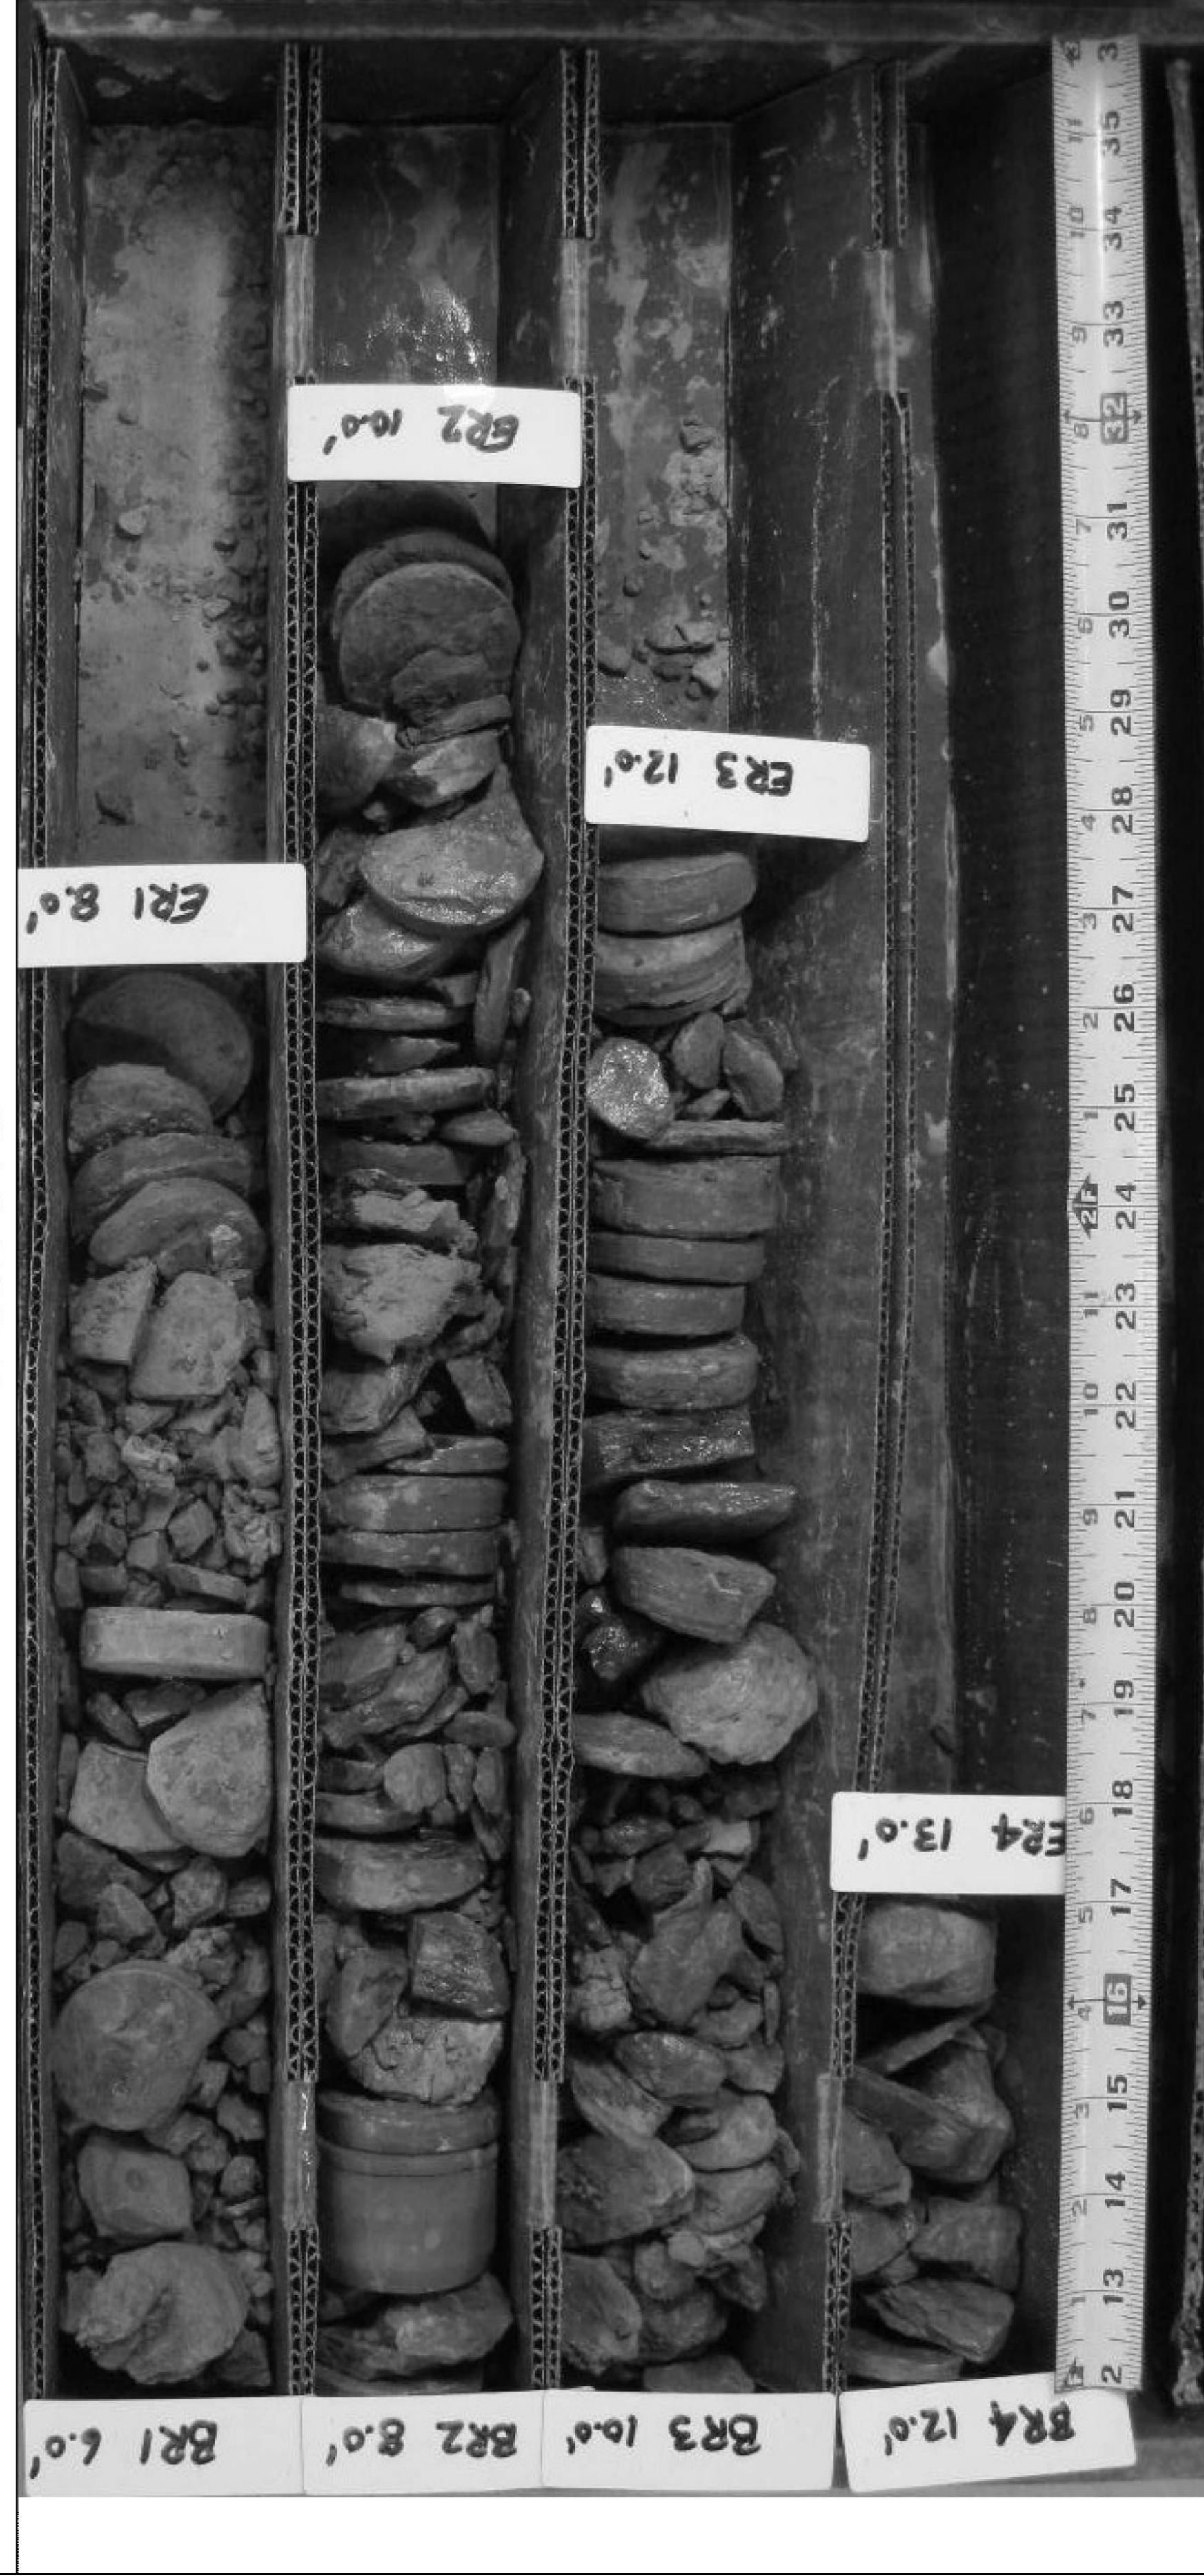
B-002-0-23

Run #:	Depth	Recovery	RQD
NQ2-1	6.0'	14/24	58%
NQ2-2	8.0'	19/24	79%
NQ2-3	10.0'	16/24	67%
NQ2-4	12.0'	5/12	42%
Mus-146-29.46 PID 115988

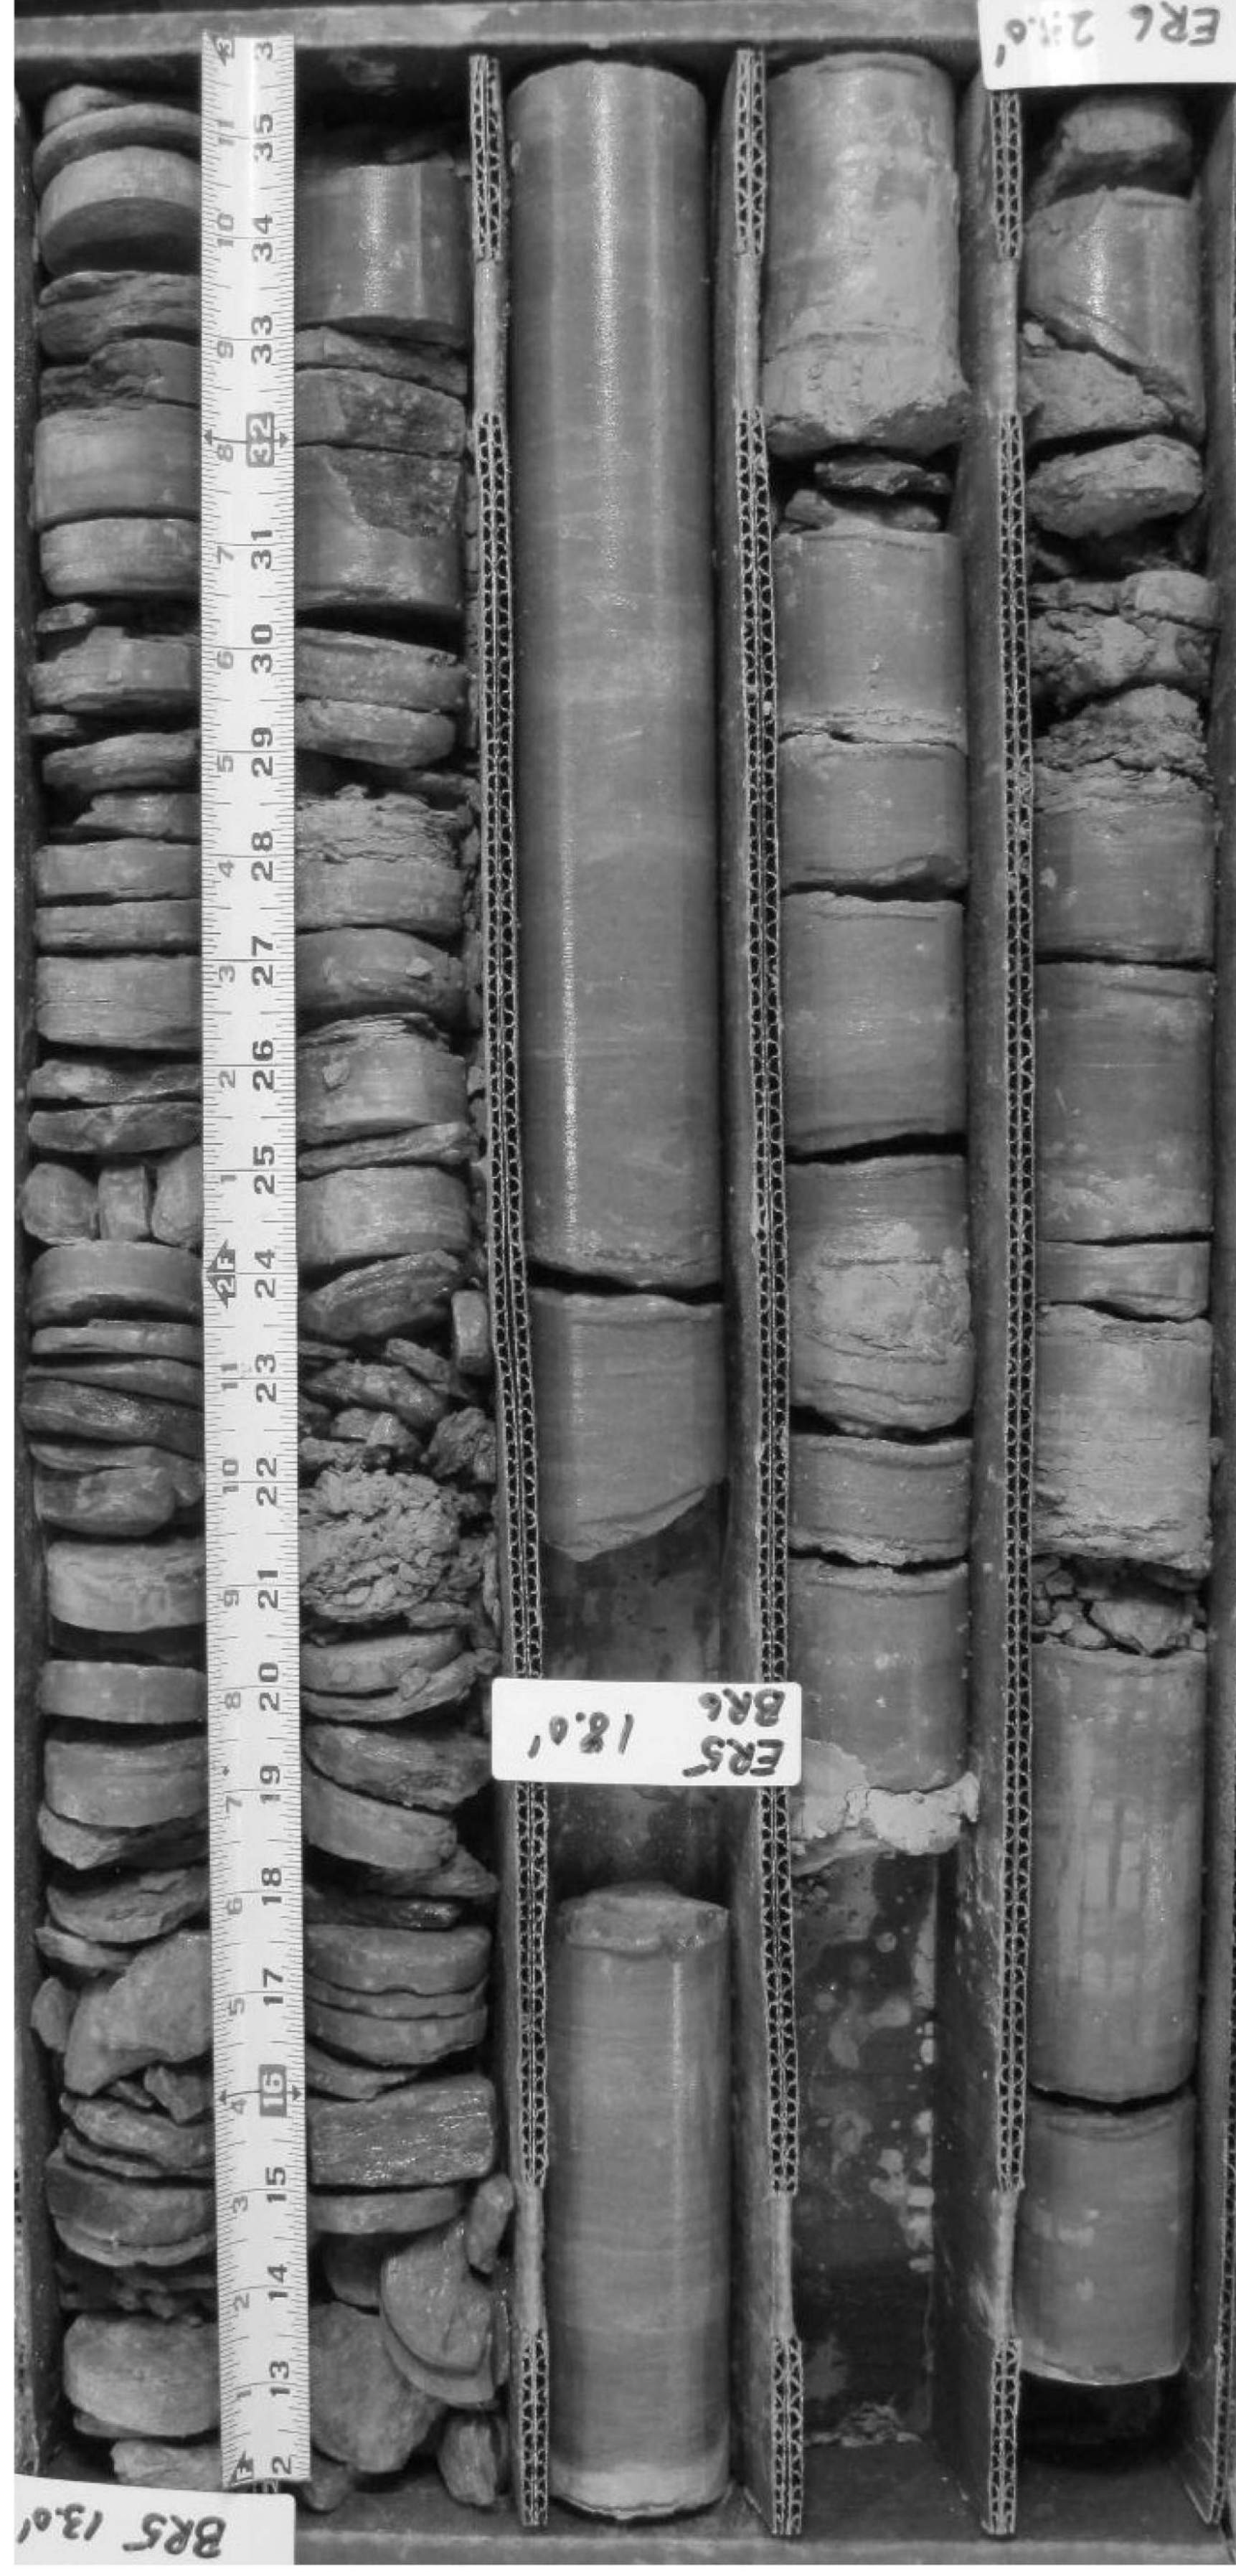
B-002-0-23

Run #:	Depth	Recovery	RQD
NQ2-5	13.0'	53/60	88%
NQ2-6	18.0'	54/60	90%
Mus-146-29.46 PID 115988

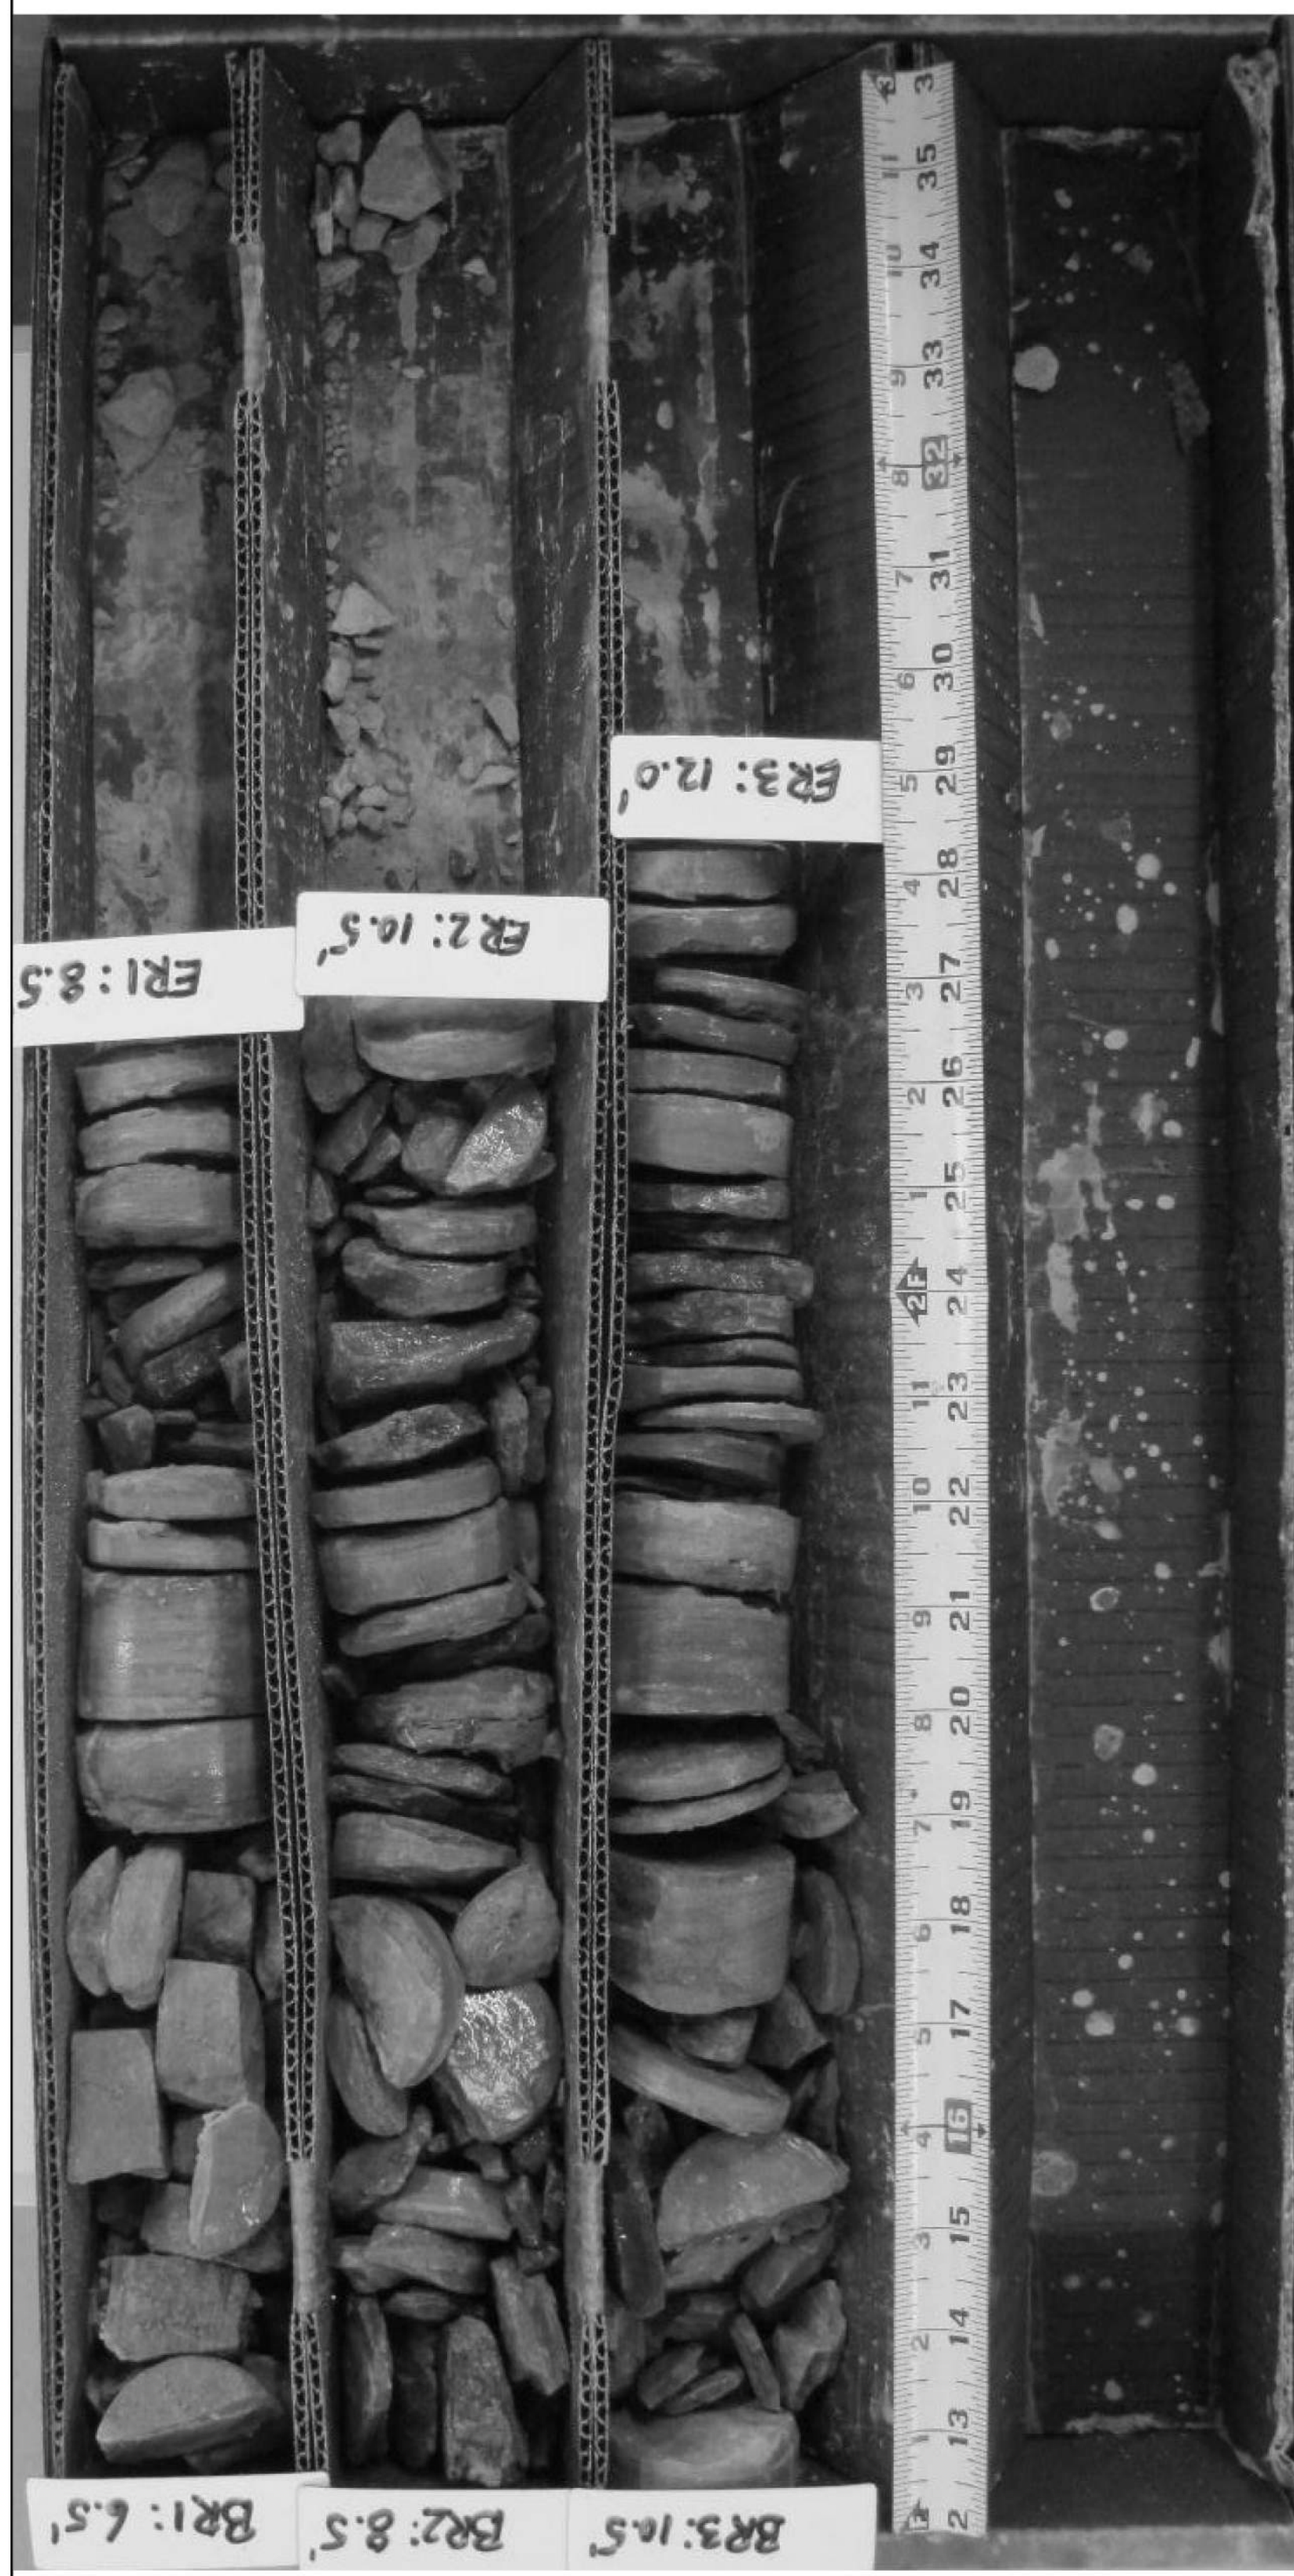
B-003-0-23

Run #:	Depth	Recovery	RQD
NQ2-1	6.5'	14/24	0/24
NQ2-2	8.5'	15/24	0/24
NQ2-3	10.5'	16/18	0/18
Mus-146-29.46 PID 115988

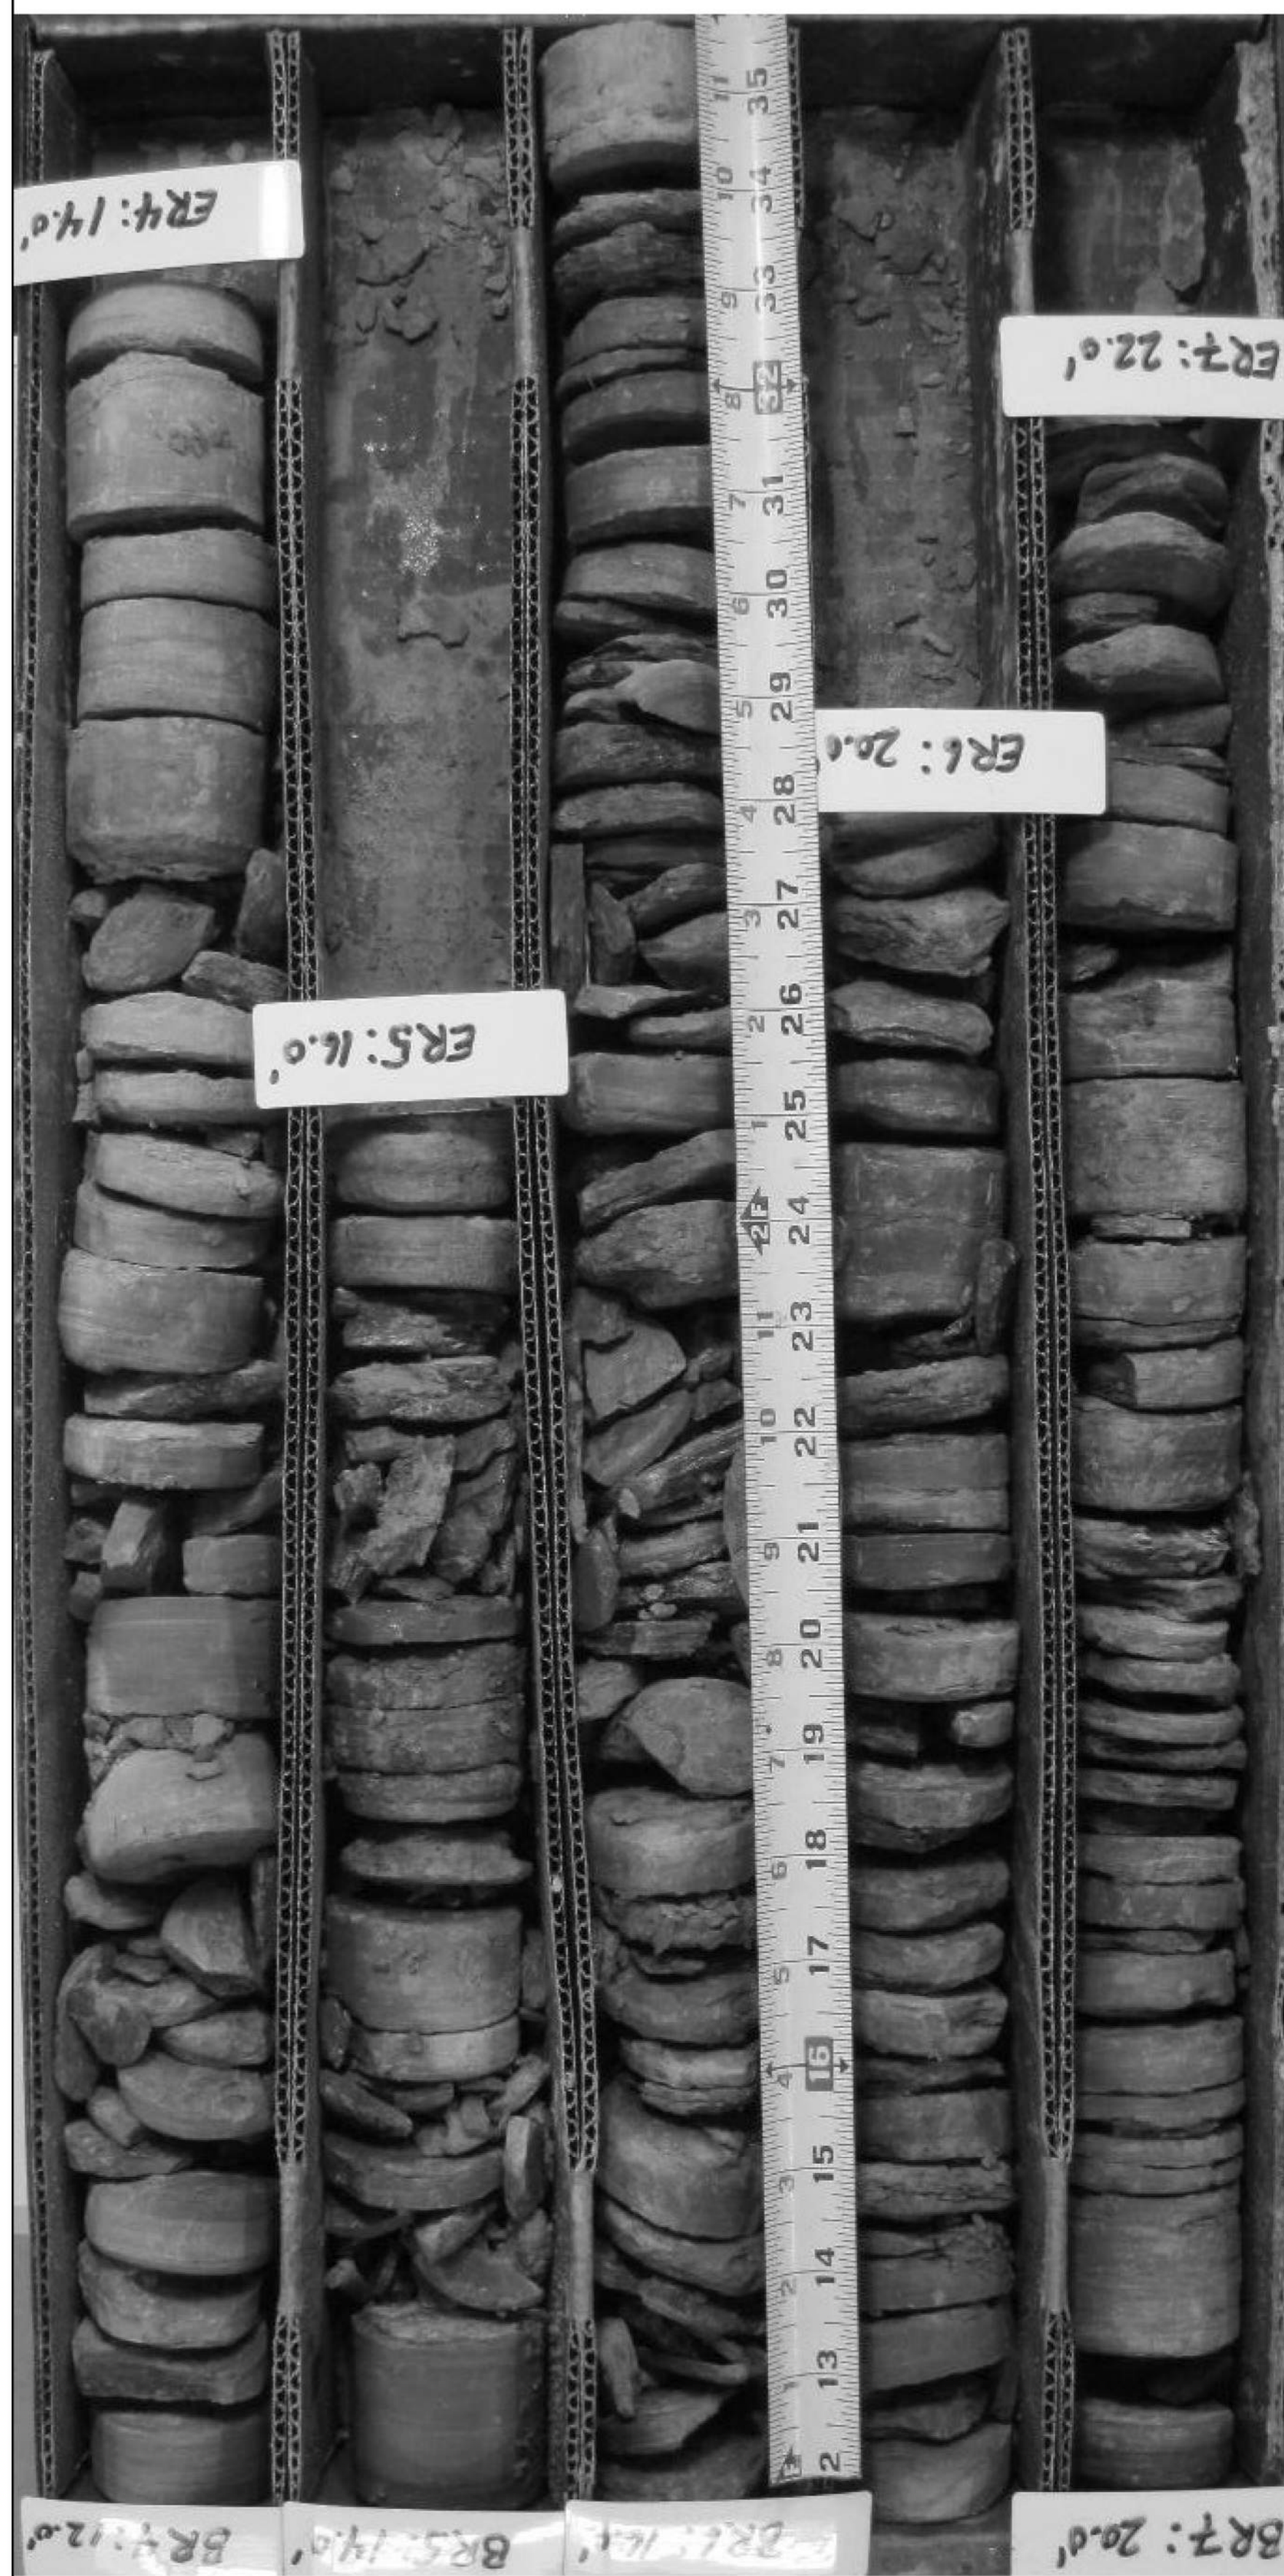
B-003-0-23

Run #:	Depth		Recovery		RQD	
	12.0'	14.0'	21/24	88%	0/24	0%
NQ2-4	12.0'	14.0'	21/24	88%	0/24	0%
NQ2-5	14.0'	16.0'	13/24	54%	0/24	0%
NQ2-6	16.0'	20.0'	41/48	85%	0/48	0%
NQ2-7	20.0'	22.0'	20/24	83%	0/24	0%

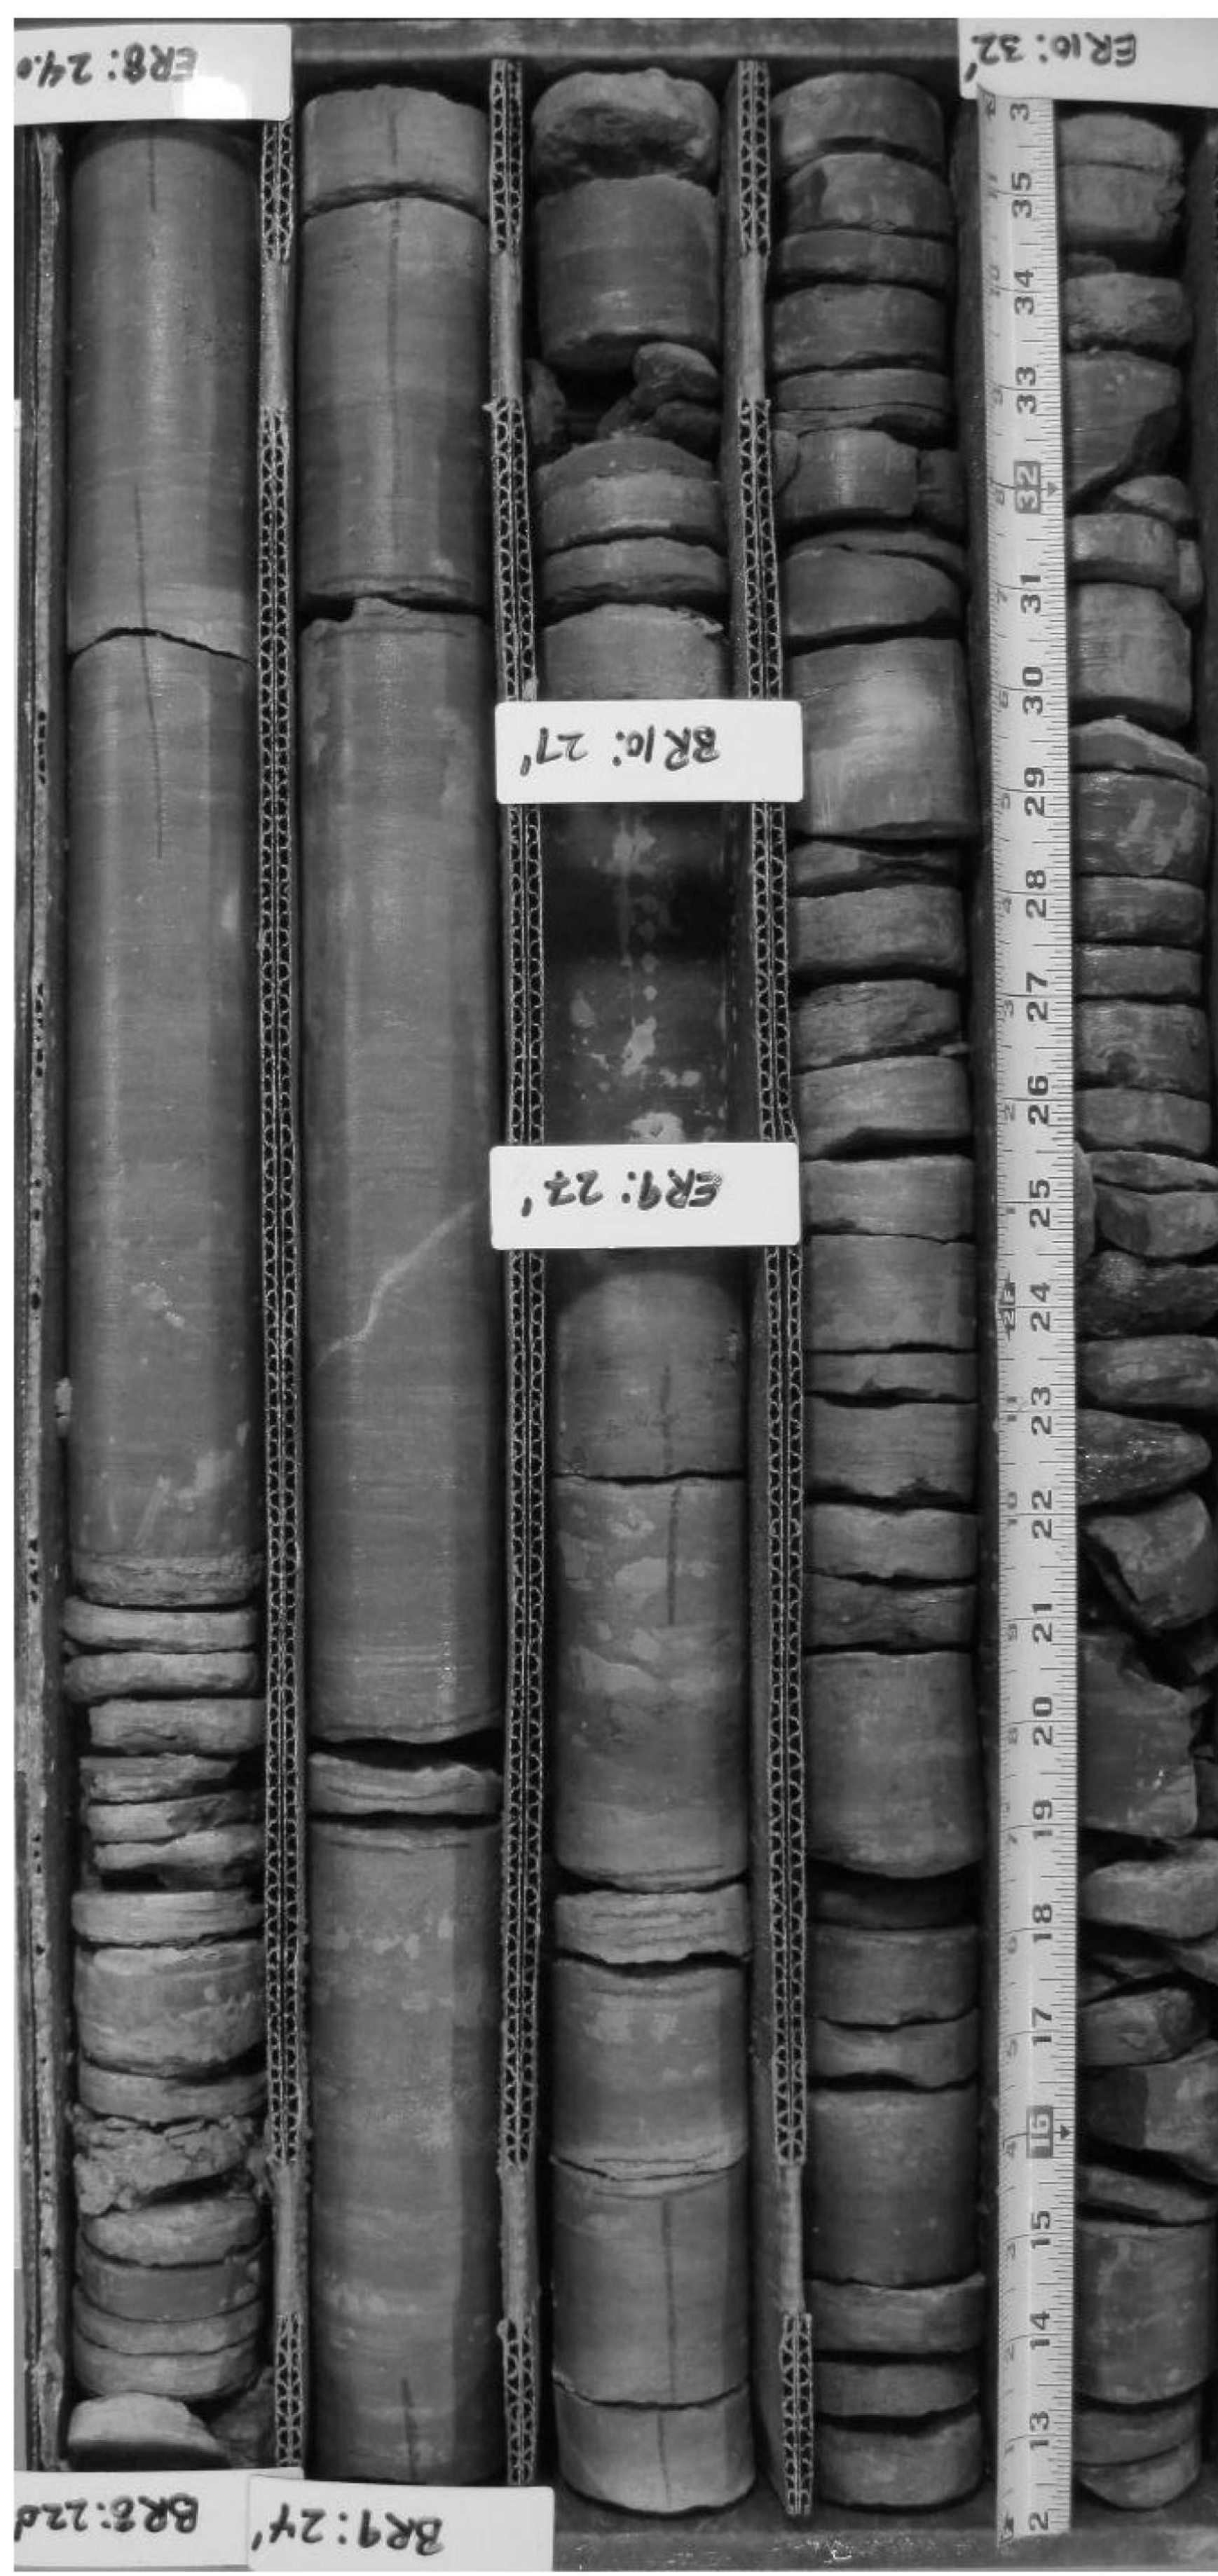
B-003-0-23

Run #:	Depth		Recovery		RQD	
	22.0'	24.0'	24/24	100%	15/24	63%
NQ2-8	22.0'	24.0'	24/24	100%	15/24	63%
NQ2-9	24.0'	27.0'	36/36	100%	32/36	89%
NQ2-10	27.0'	32.0'	55/60	92%	0/60	0%

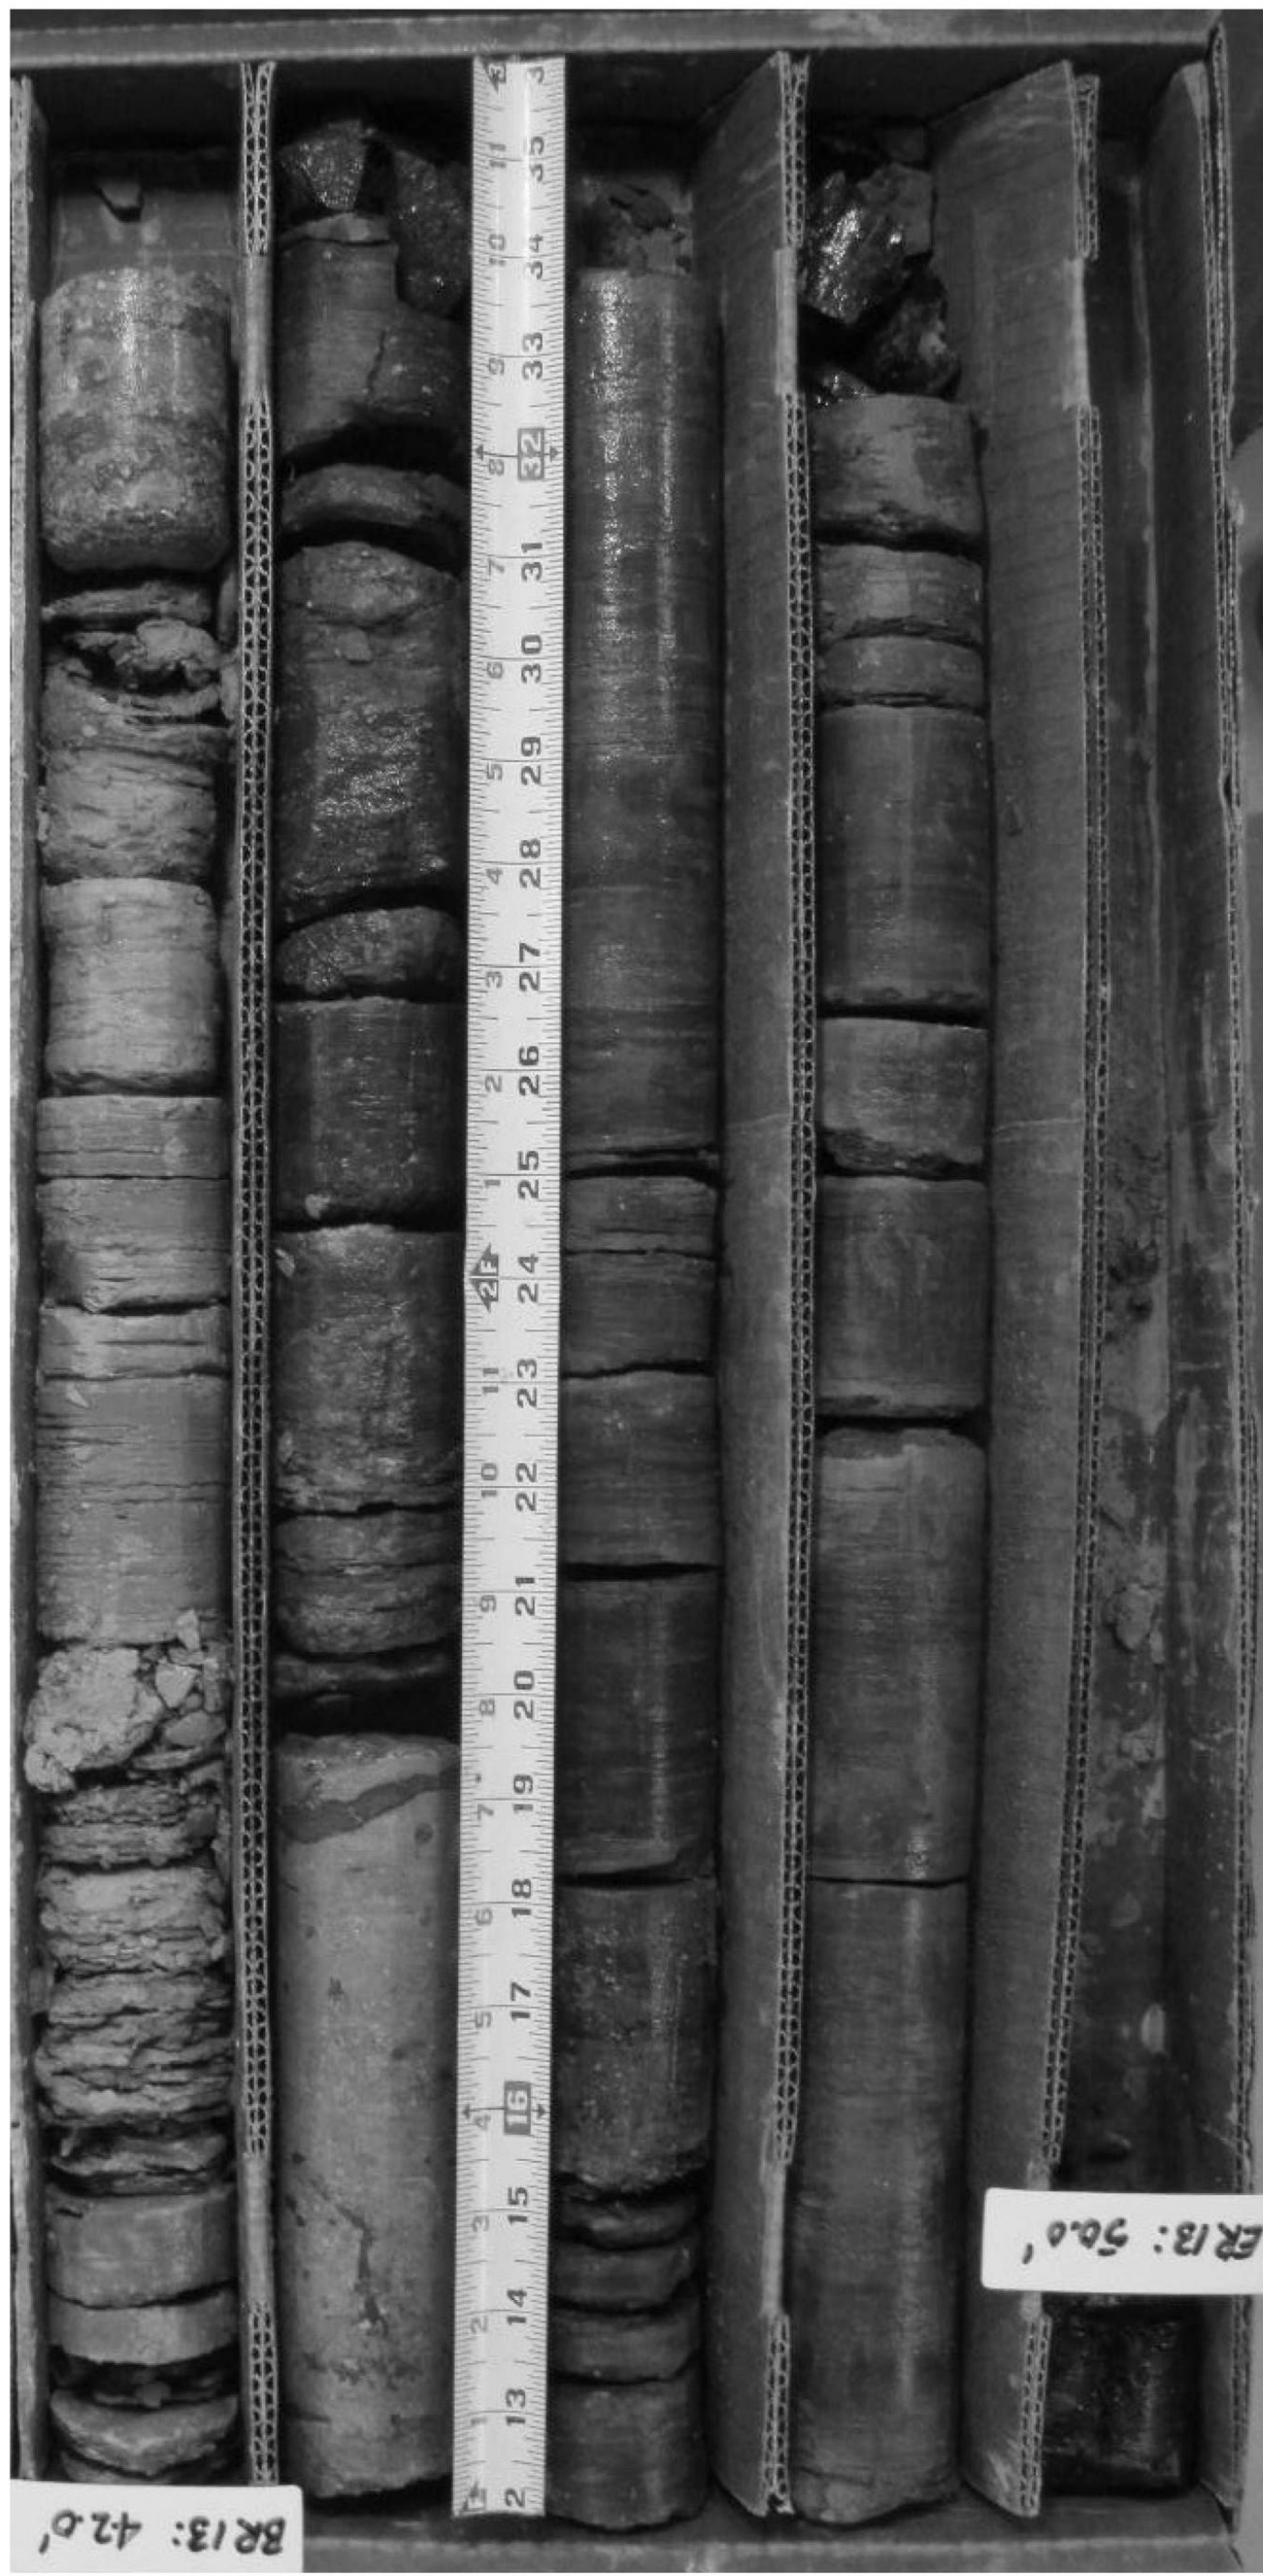
B-003-0-23

Run #:	Depth	Recovery	RQD
NQ2-13	42.0'	93/96	41/96
Mus-146-29.46 PID 115988
